PHASE I REPORT
NATIONAL DAM INSPECTION PROGRAM

NAME OF DAM: Indian Lake Dam
STATE LOCATED: Pennsylvania
STREAM: Calendar Run, secondary tributary of Stoney Creek, a tributary
of the Conemaugh River
DATE OF INSPECTION: (May 17 and 30, 1978),

National Dam Inspection Program, Indian
Lake Dam (NDI ID Number 228), Ohio
River Basin, Calendars Run, Somerset
County, Pennsylvania. Phase I Inspection
Report.

PHASE I
NATIONAL DAM INSPECTION PROGRAM
INDIAN LAKE DAM
NDI I.D. NO. 228
DER I.D. NO. 56-103

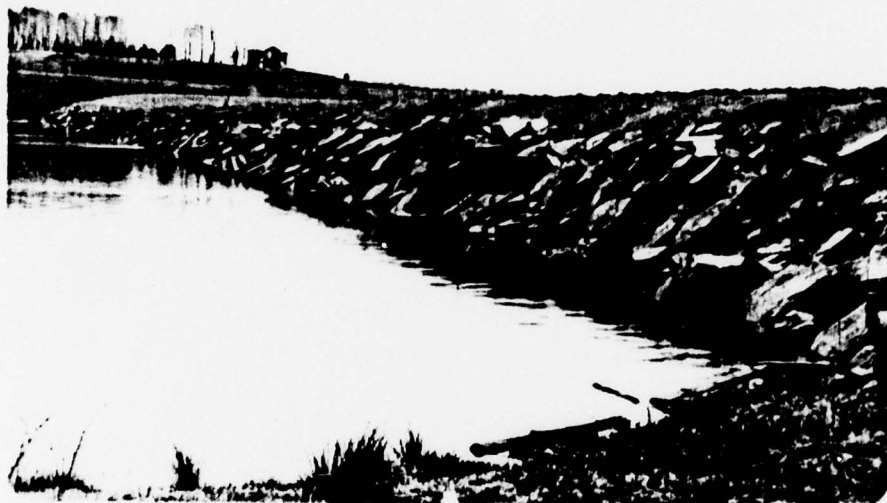
Upstream Face
